BioMax Environmental

**Microbial Assessment and Mitigation Procedures -
First Floor Security Kiosk Area
Department of General Services Board of Equalization Building
450 N. Street
Sacramento, California**

Attachment A: Digital ImagesApril 29th, 2008BOE Building 1st Floor Security Kiosk Area
Sacramento, CA

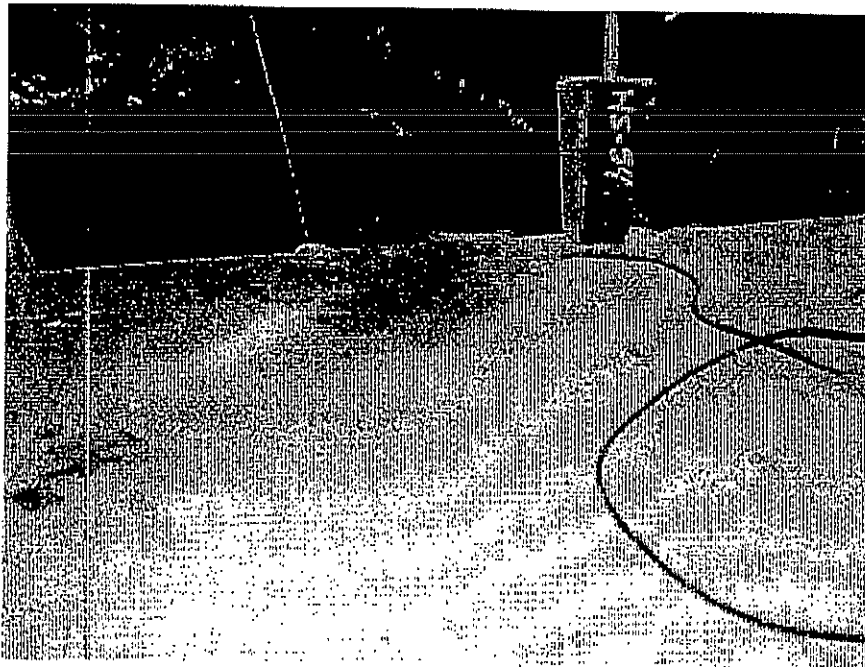
- 4) Image of stained sheetrock material associated with chronic moisture release from HVAC systems.

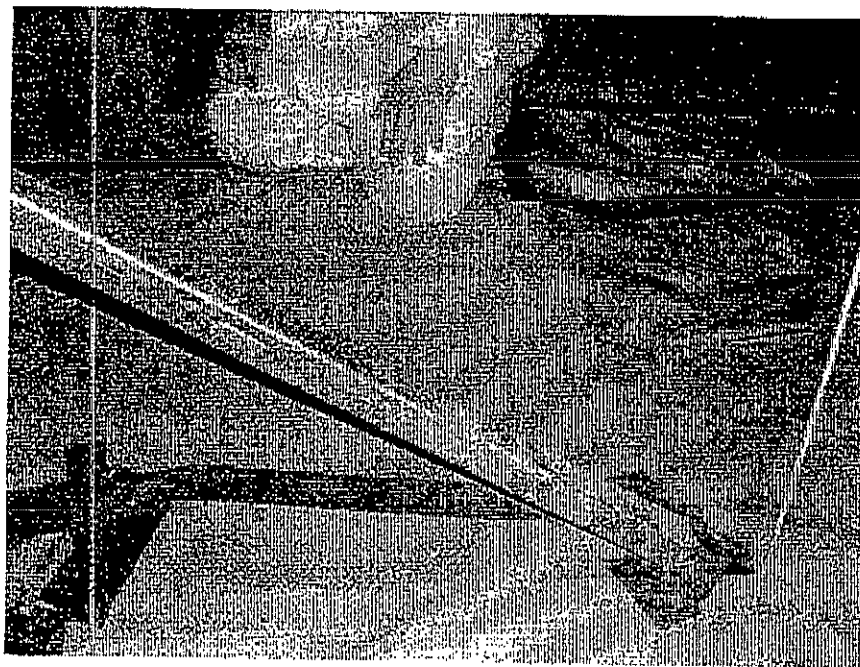
- 6) Additional image of plastic barriers which were opened to gain access for inspection and sampling of affected materials.

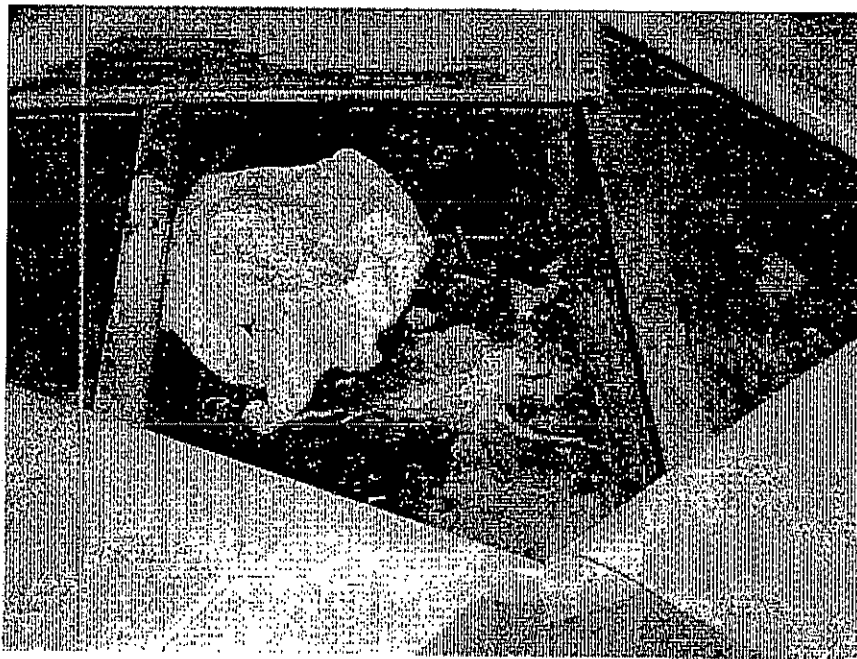
Sample Number	Sample Material and Location	Mold Genera Identified Present
S01	Sheetrock surface to right of entry - 1, dark staining present	Elevated Stachybotrys mold spores identified (500 counts)
S02	Sheetrock surface to right of entry - 2, dark staining present	Elevated Stachybotrys (750 counts) and Penicillium/Aspergillus type spores (600 counts) identified
S03	Sheetrock surface to left of entry - 1, w/ light "fuzzy" deposits present	Penicillium/Aspergillus (12 counts) and Cladosporium (24 counts) identified.
S04	Sheetrock surface to left of entry - 2, w/ light "fuzzy" deposits present	Penicillium/Aspergillus (55 counts) and Cladosporium (8 counts) identified.
S05	Field control Blank Sample	No mold spores identified
S06	Sheetrock surface out of impacted area, w/ light "fuzzy" deposits present	Penicillium/Aspergillus (42 counts), Cladosporium (72 counts), Smuts (11 counts), and Basidiospores (10 counts) identified.

B01	Bulk sheetrock paper sample under HVAC unit w/black staining present	Elevated Stachybotrys mold spores identified (1,000 counts)

- 7) Close-up image of stained materials within ceiling materials of bay directly beneath HVAC system. Samples B01 and S01 collected from such materials.

10. **Removal of Damaged Materials** - BioMax specifically recommends that all physically stained and/or mold damaged materials (such as impacted sheetrock and plywood materials) be inspected and removed under containment controls. As verified through visual inspection, any stained and/or moisture/mold affected interior sheetrock and building materials should be removed, wherever feasible, to the extent of visible staining, at a minimum. All visibly damaged plywood walk-way floor materials associated with the plenum area HVAC equipment shall also be removed and disposed under containment controls for appropriate inspection of underlayment materials. Removal of moisture impacted and mold damaged materials may employ the use of supplemental item-specific containment methods and systems (such as sealed plastic glove-bag containment systems, or equivalent) applicable to the materials being removed at the option of the mitigation contractor and direction of the Project CIH. BioMax currently anticipates that all visually affected ceiling sheetrock and plywood HVAC unit flooring materials present within the plenum space shall be removed for disposal, and physical inspection of underlayment surfaces, as necessary. All sheetrock exhibiting elevated moisture content and/or staining within adjacent areas shall be similarly removed as necessary. Any underlayment materials exhibiting visible signs of moisture staining shall also be removed or decontaminated, as necessary.

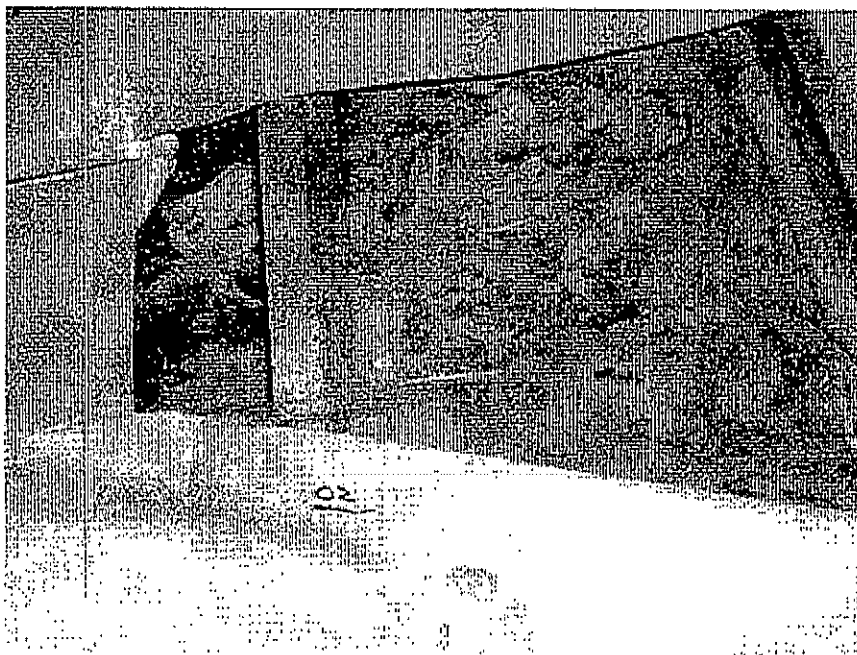
9) Image of adjacent bay cavity where Sample S02 was collected within impacted area.

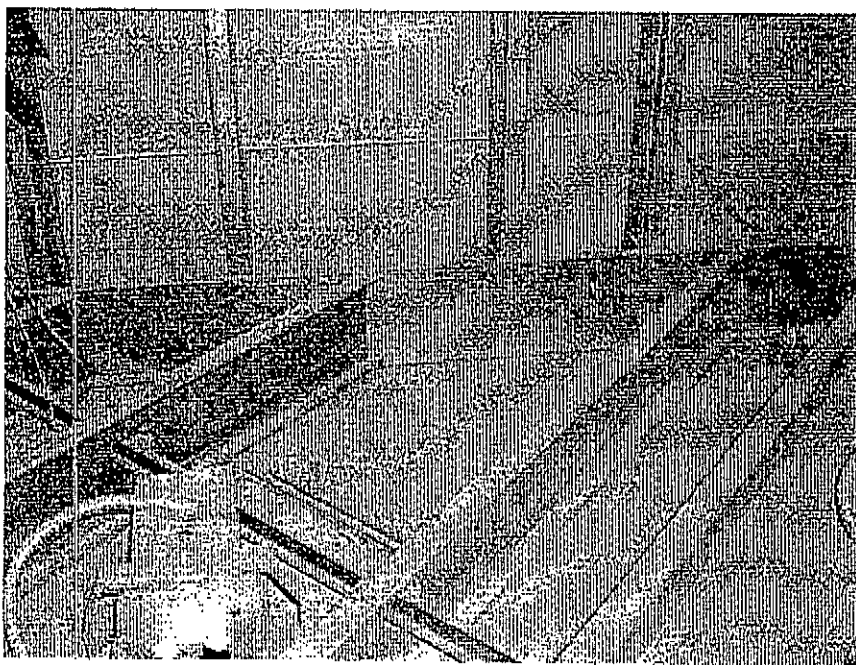
10) Image within ceiling plenum area away from impacted materials where surface control sample S06 was collected from horizontal surface in north corner of space.
